Replacement powder unit for AGA DTF XP Premium Combo printer

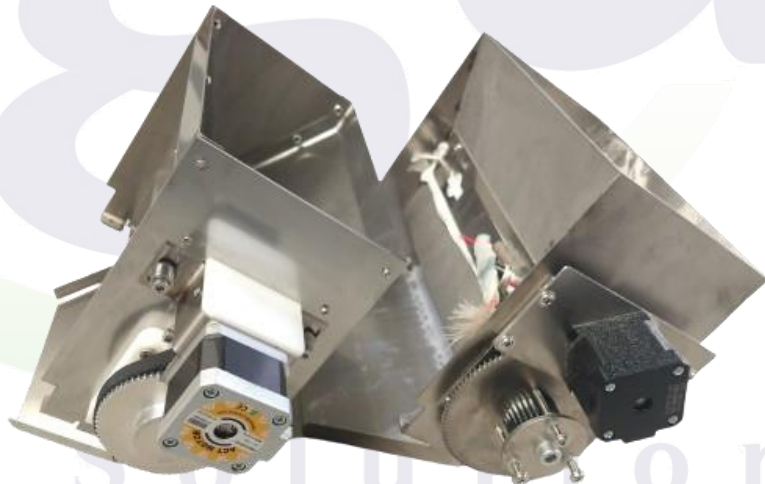
- 1) Hot melt powder is leaking from the bin even when the machine is not running.
- 2) The bearings used are an open type and mounted in such a way that hot melt glue enters the bearings, causing the bearings to malfunction.
- 3) The stepping motor is underpowered.
- 4) The gears are made of laser cut thin steel plate material and are not sturdy.

Picture 1: original unit on right hand side, redesigned unit on left hand side

- 1) A brush system is used for powder dosing.
- 2) Proper ball bearings are used for the rotating shaft.
- 3) A high-quality stepper motor is used.
- 4) Instead of rickety gears, a rubber drive belt is used to transfer the power from the motor to the axle.

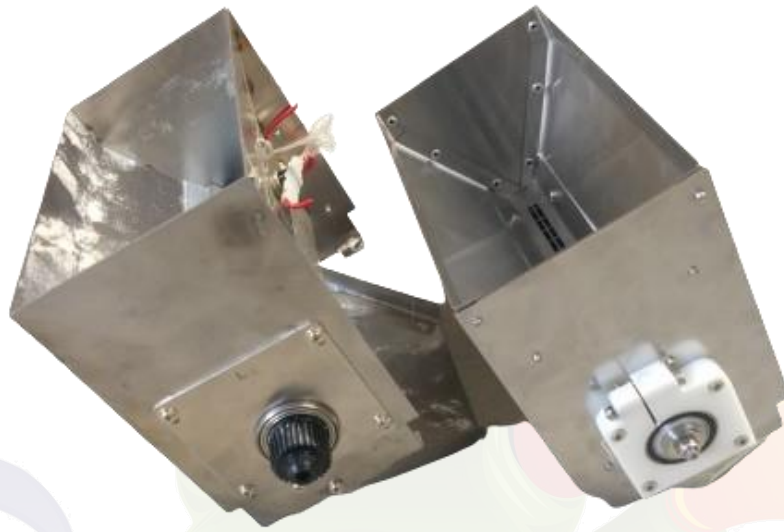
Picture 2: original unit on left hand side, redesigned unit on right hand side

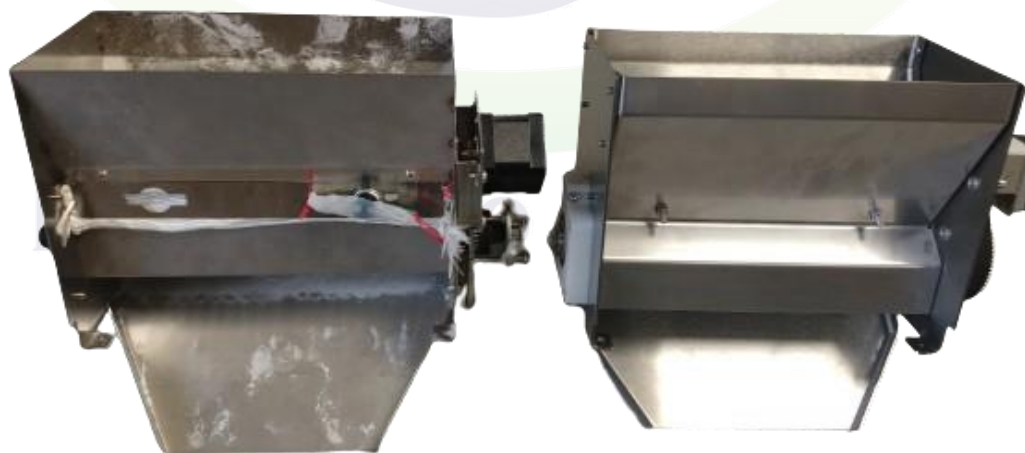
Picture 3: original unit on right hand side, redesigned unit on left hand side
